Pumped Transfer of Liquefied Gases

Felix Ochsner*

Abstract: The transfer of liquefied gases comprises a special hazard potential. Therefore special equipment and expertise is necessary. It is not possible for every HazMat base to hold its own equipment. Therefore in Switzerland the Flüssiggaspikett der Ostschweiz and DSM Nutritional Products, Sisseln, can be called out to provide help if incidents with liquefied gases occur. A case study of a real mission is presented. Furthermore technical specifications of key items and the experience of the author are provided.

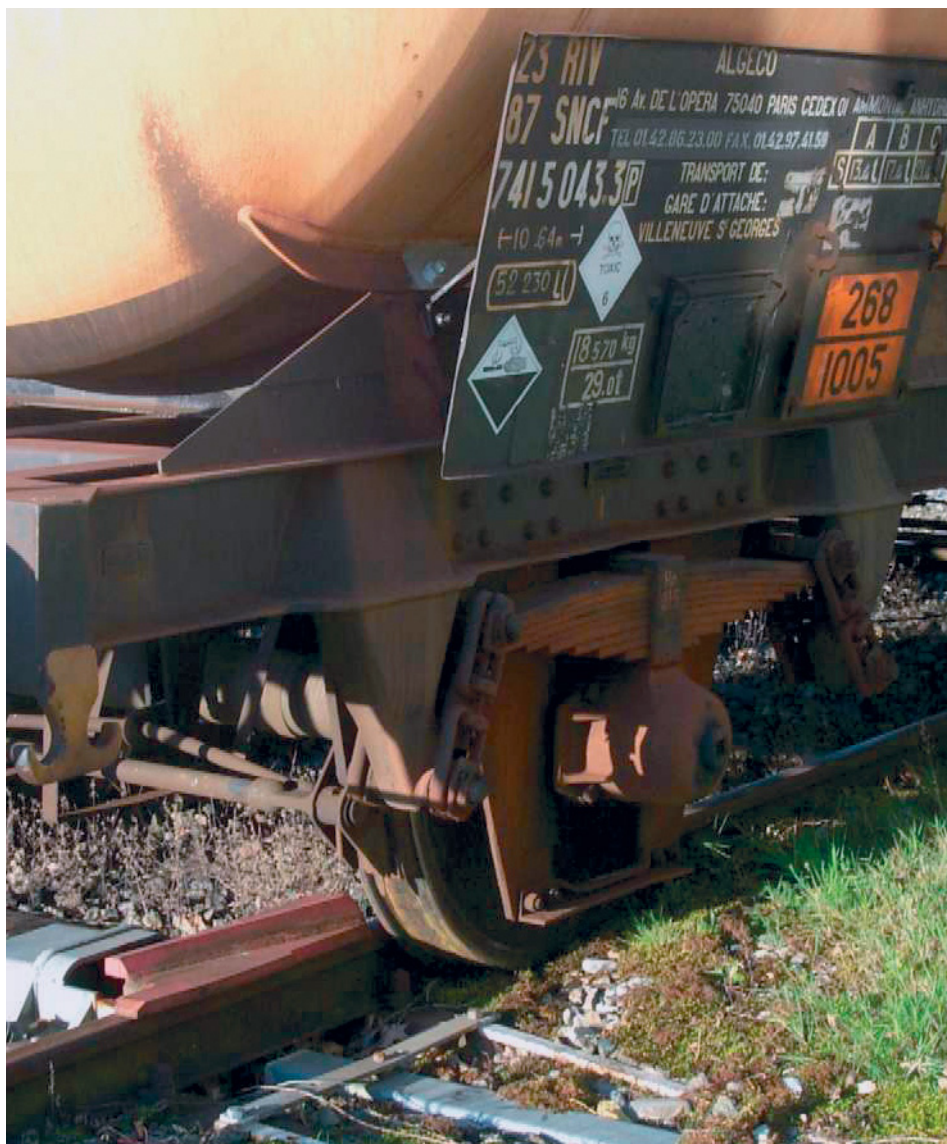
Fig. 1. Derailed wagon with some twenty tonnes of ammonia. The stumbling block as cause of the derailment is visible; next to the wheel.

On the morning of October 3, 2001, a rail tank wagon loaded with some 20 t ammonia was derailed on an industrial siding as a result of operator error (Fig. 1). The derailed wagon came to rest on the ballast immediately next to the track and was not damaged. Despite this, the railway manage-

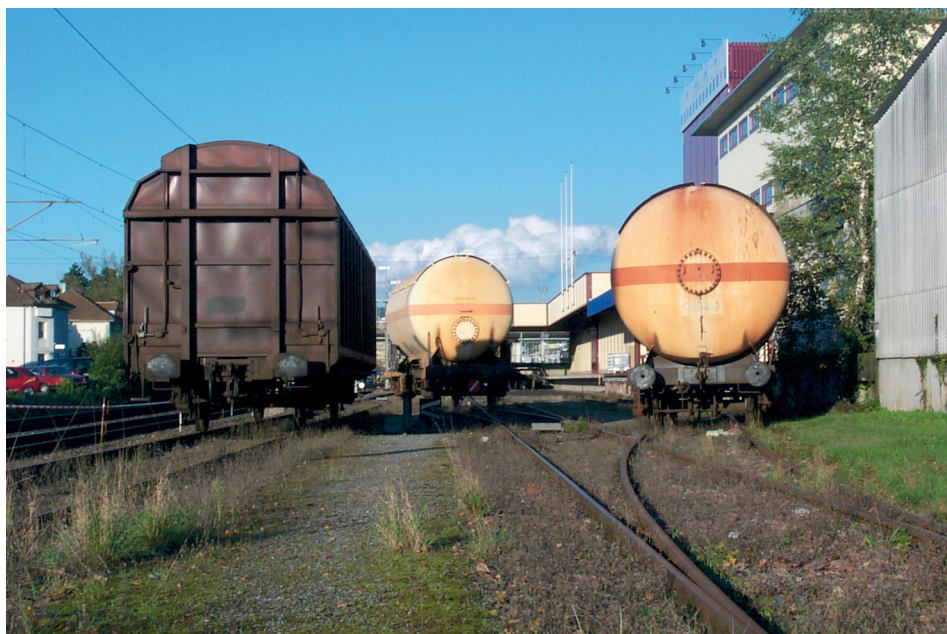
Fig. 2. General overview with railway line Zurich-Bern left, industrial buildings, derailed wagon right and recovery wagon in the middle.

- The industrial siding is located some 10 m away from the Zurich-Brugg-Bern railway line. (Fig. 2).
- Beyond the railway line a main road runs parallel to it.

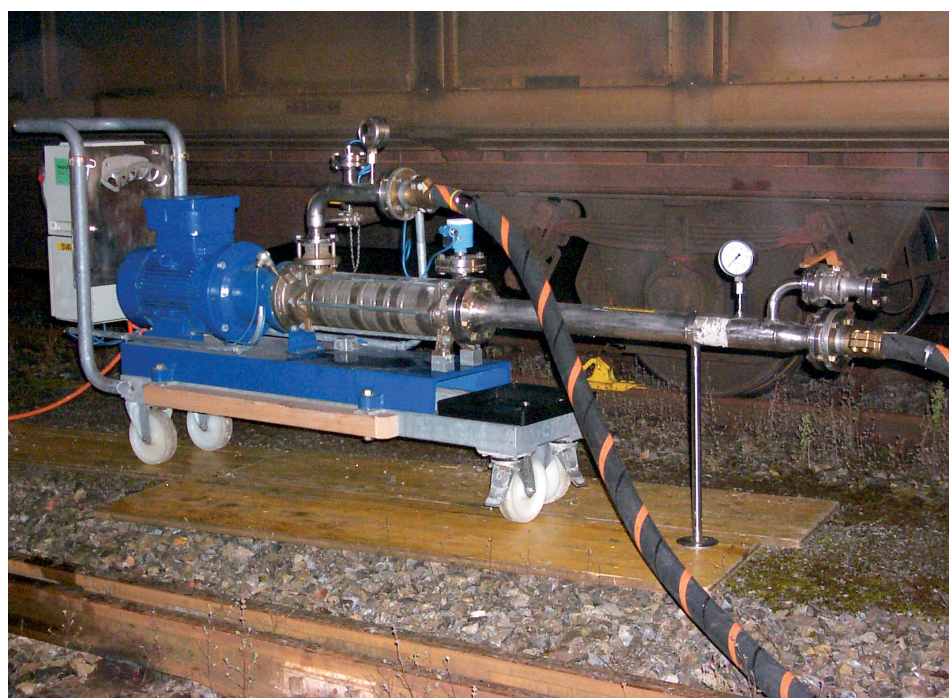
Fig. 3. Liquefied gas pump with suction hose connected with casing and pressure hose above. For technical specifications see text.

Liquefied gas pump (Fig. 3):	
Make, type:	SIHI CEHY 4107/6 1F9AK4B4S, self-priming, low NPSH required
Capacity:	max. 30 m ³ /h
Total head:	approx. 110 m
Allowable pressure:	40 bar
Temperature range:	-40 °C to 120 °C
Casing pressure rating:	PN 25
Sealing technique:	canned motor
Drive:	canned motor
Motor rating:	37 kW
Casing gasket:	Teflon
Interlocks:	low level switch and low flow rate switch
Pressure hoses:	
Make, type:	Butapal-SD DN050 PO50BUW high pressure hose for liquefied gas to DIN 4815/3
Material:	NBR
Inner wall:	homogeneously smooth
Nominal diameter:	DN 50
Flanges:	DN 50 PN 40
Temperature range:	-40 °C to +70 °C
Operating pressure:	25 bar with a safety factor of at least 4
Vacuum rating:	0.8 bar absolute
Earthing:	manufactured with an integral steel wire helix and copper braid to dissipate electrostatic charge
